Flood Control Project Maintenance
Levee Inspections

Fall 2013 Levee Maintenance Deficiency Summary Report

Sacramento River Basin

| RD0999 Reclamation District No. 0999 Netherlands | Overall LMA Rating | Total LMA Miles | | | | | | | |

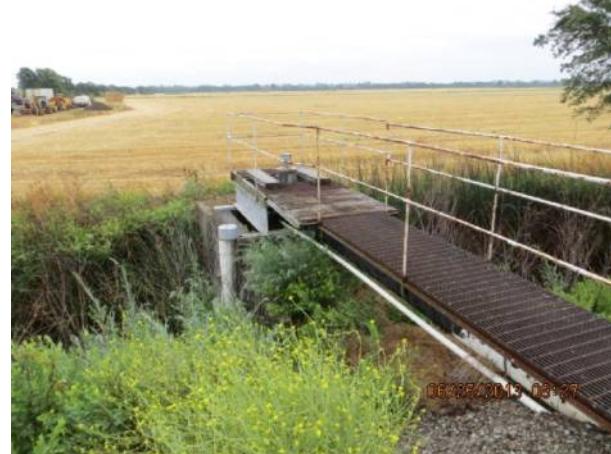
| UCIP_8113.jpg | |

| Walkway and pump off LS toe. | |

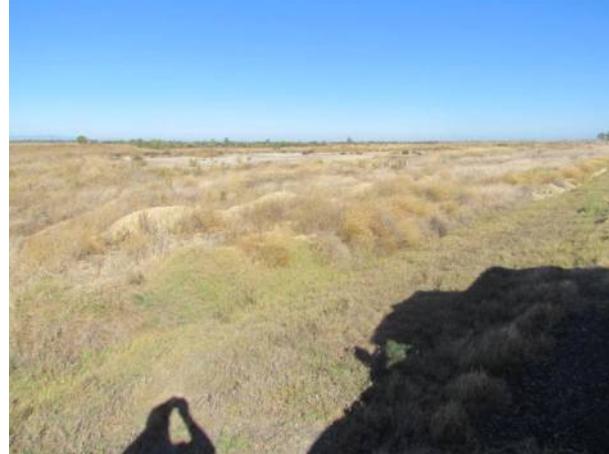
| richard_f_20130927_459.JPG | |

| Looking west at fill on waterward berm. 2013 | |

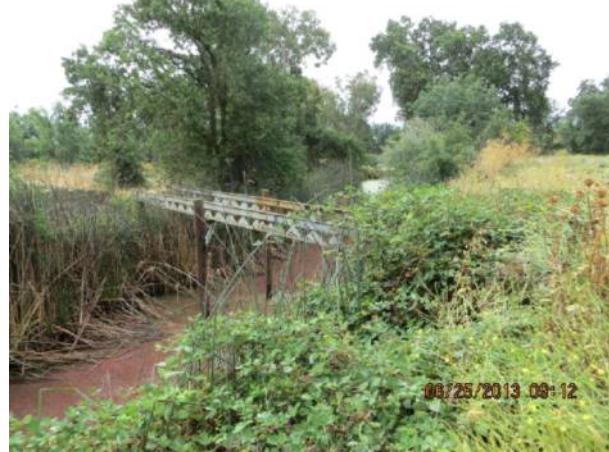
| UCIP_8122.jpg | |

| Pump platform visible off LS toe, but no appurtenances remain. | |

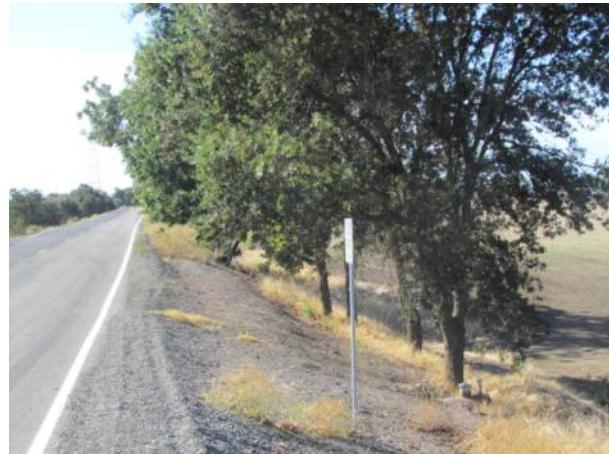
| richard_f_20130927_460.JPG | |

| Looking southwest at trimmed trees on waterward slope. | |

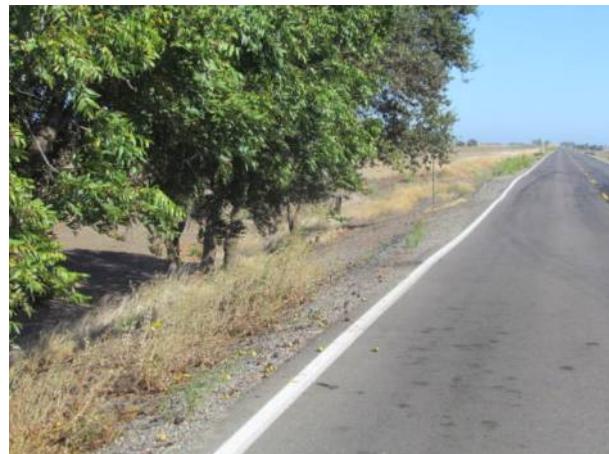
| richard_f_20130927_461.JPG | |

| Looking northwest at trimmed trees on waterward slope. | |

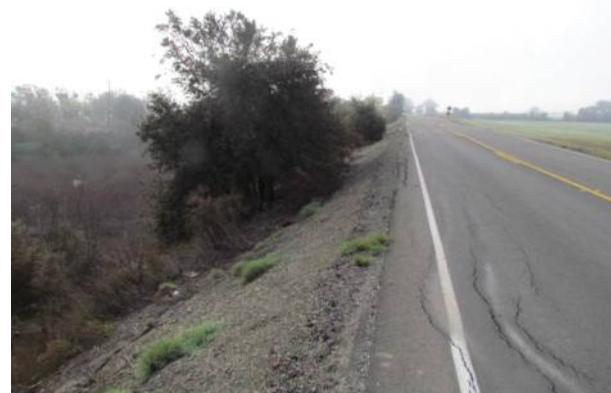
| richard_f_20130918_243.JPG | |

| Looking southeast at untrimmed tree on landside slope and toe. | |

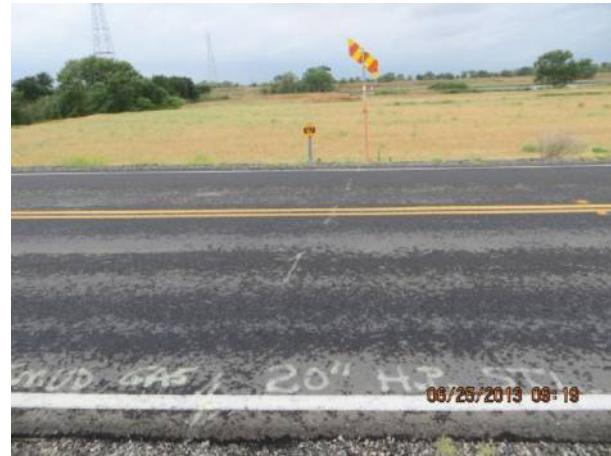
| UCIP_9054.jpg | |

| Gasline markers on WS shoulder with USAA paint on roadway. | |

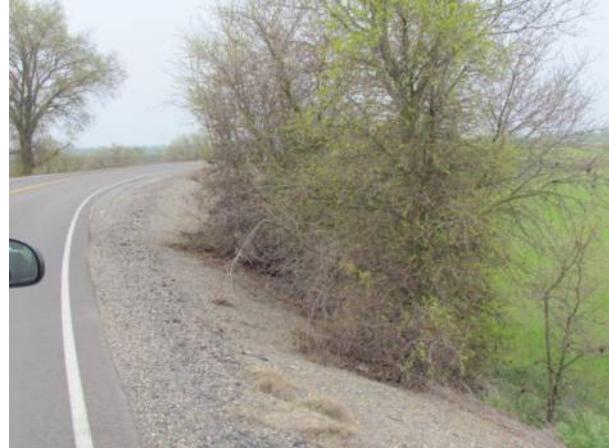
| richard_f_20130918_224.jpg | |

| Looking southwest at untrimmed trees on waterside slope. | |

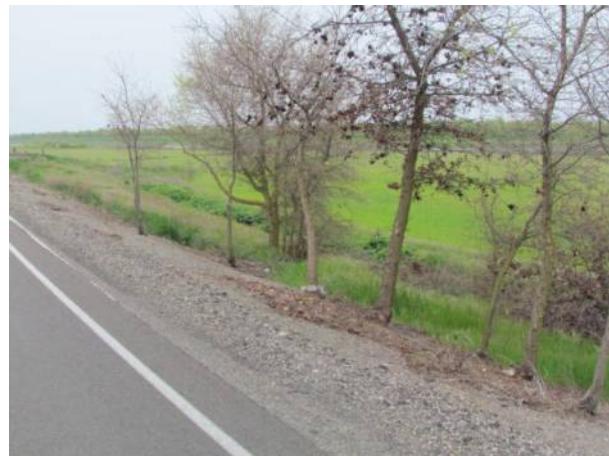
| richard_f_20130918_225.jpg | |

| Looking southwest at trimmed trees on waterside slope. (Spring 2012) | |

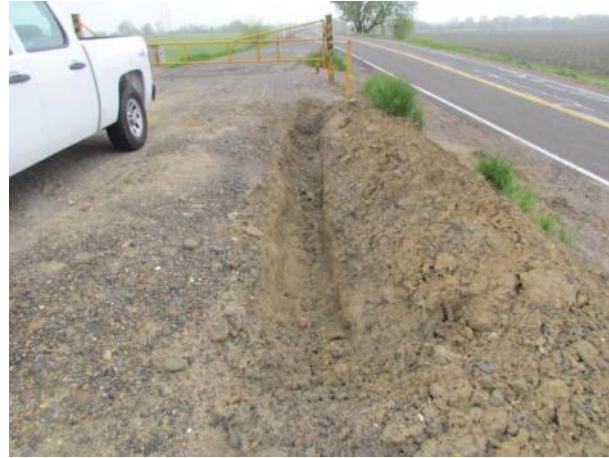
| richard_f_20130918_251.jpg | |

| Looking north at excavation on landside shoulder. | |

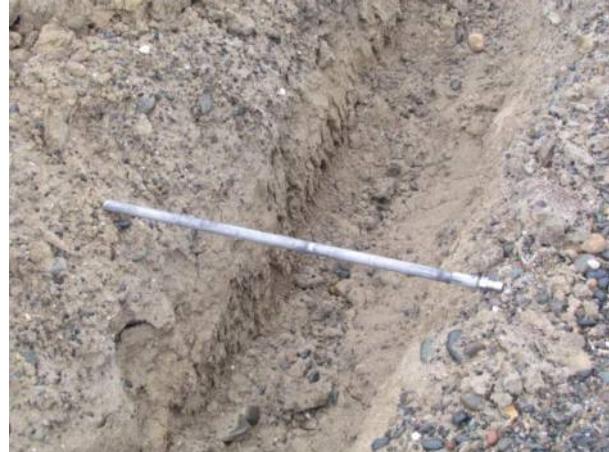
| richard_f_20130918_252.jpg | |

| Looking south at close-up view of excavation on landside shoulder. | |

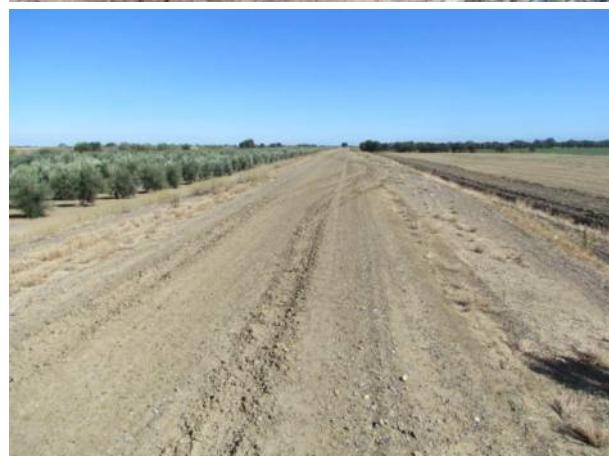
| richard_f_20130927_462.JPG | |

| Looking north at rutting on levee crown. | |

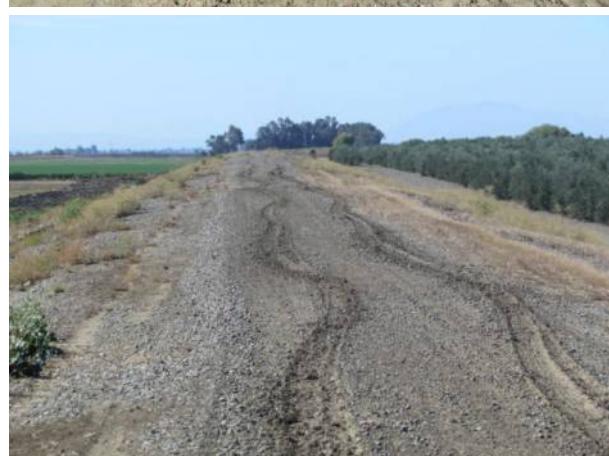
| richard_f_20130927_463.JPG | |

| Looking south at rutting on levee crown. | |

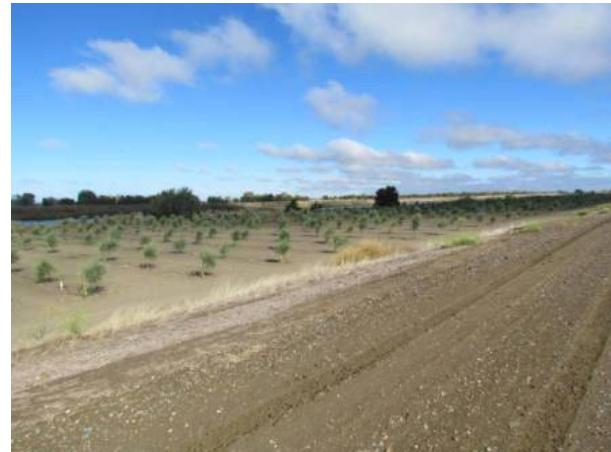
| richard_f_20130918_219.jpg | |

| Looking northwest at olive grove on waterside berm at upstream end. | |

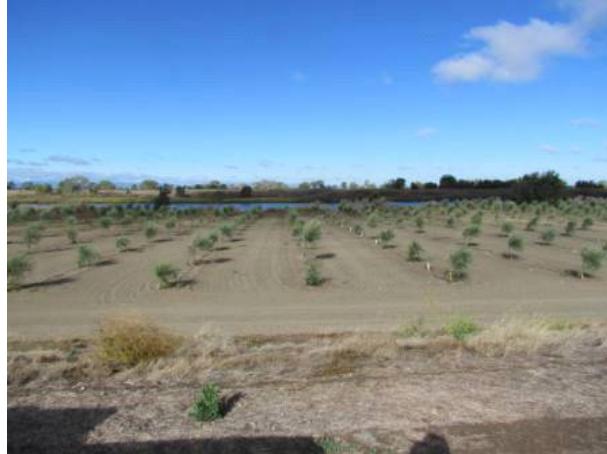
| richard_f_20130918_220.jpg | |

| Looking west at olive grove on waterside berm. | |

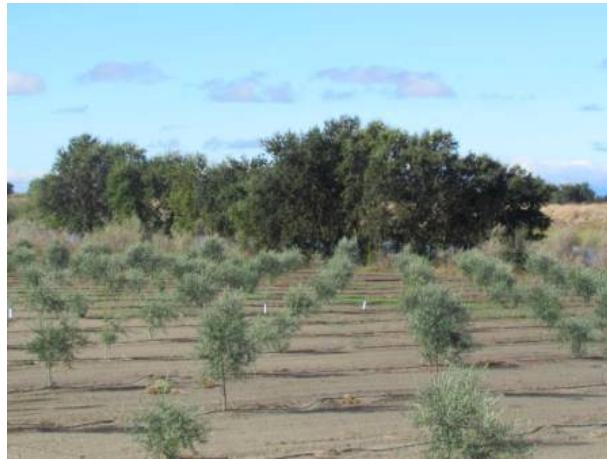
| richard_f_20130918_221.jpg | |

| Looking southwest at olive grove on waterside berm at downstream end. | |

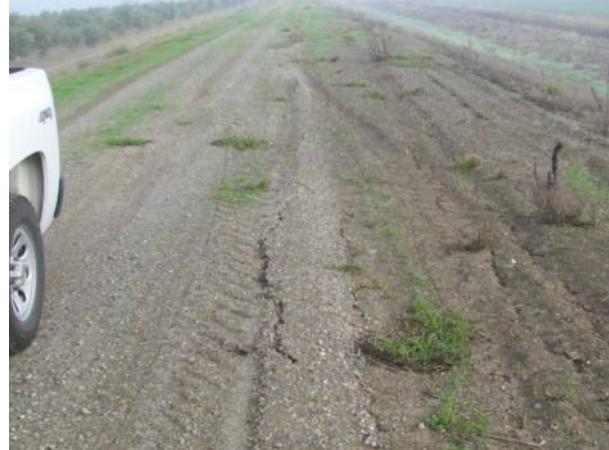
| richard_f_20130918_223.JPG | |

| Looking north at sloughing on landside shoulder and slope. | |

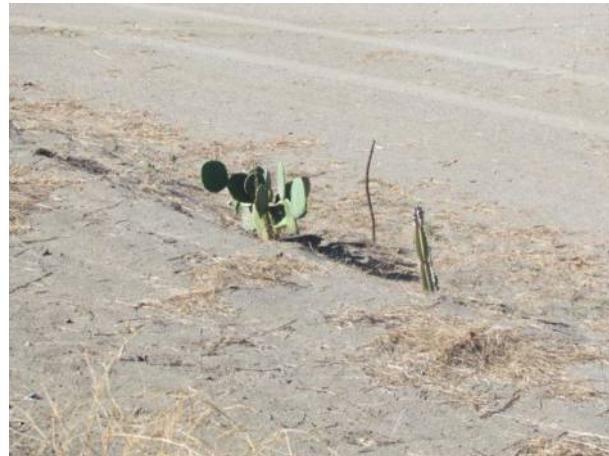
| richard_f_20130927_464.JPG | |

| Looking west at cactus on waterward toe. | |

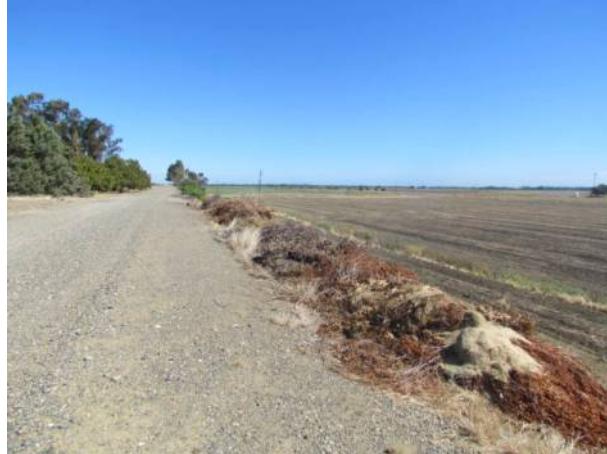
| richard_f_20130927_465.JPG | |

| Looking southeast at prunings on landward shoulder and slope. | |

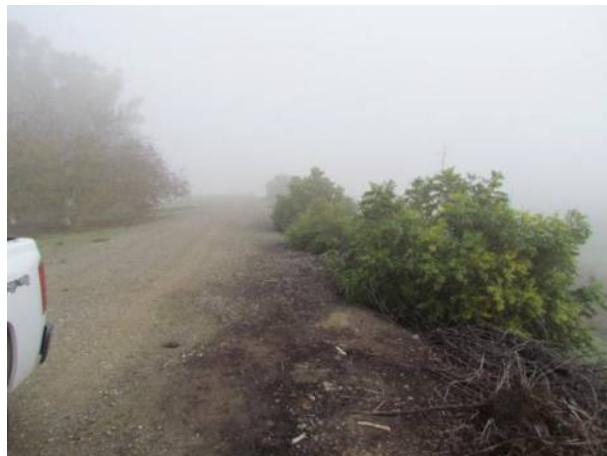
| richard_f_20130918_242.JPG | |

| Looking northeast at untrimmed trees on landside shoulder and slope. | |

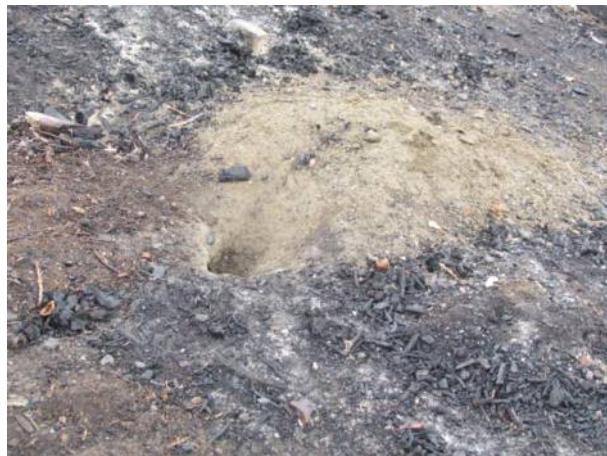
| richard_f_20130918_253.jpg | |

| Looking at typical rodent hole on landside slope. | |

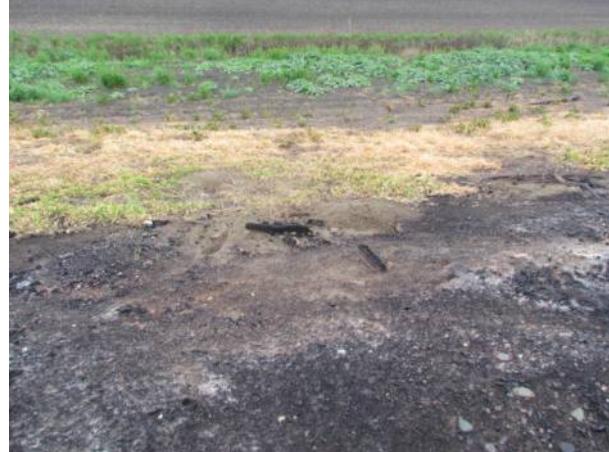
| richard_f_20130918_254.jpg | |

| Looking east at rodent holes on landside slope. | |

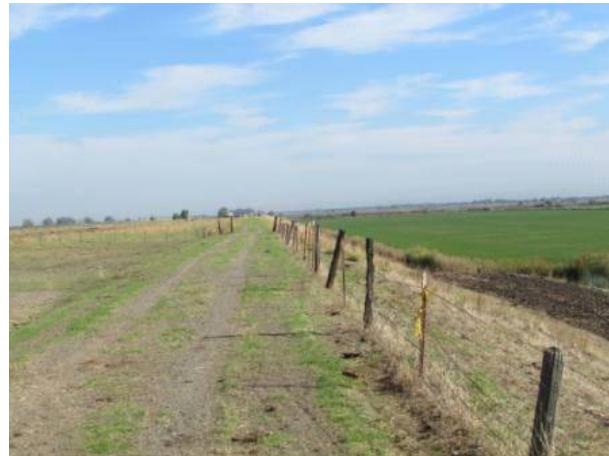
| richard_f_20130918_262.jpg | |

| Looking north at fence along landside shoulder. | |

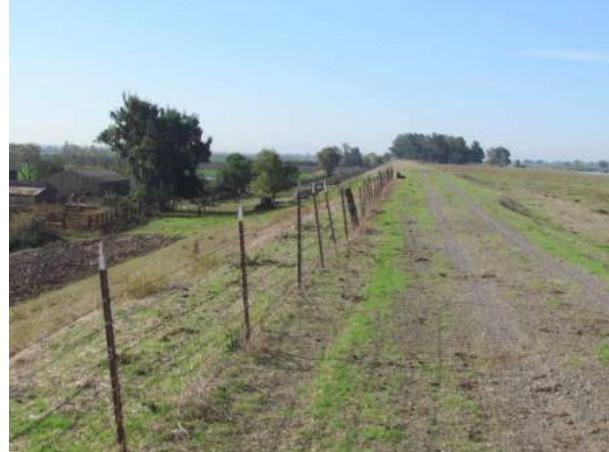
| richard_f_20130918_263.jpg | |

| Looking south at fence along landside shoulder. | |

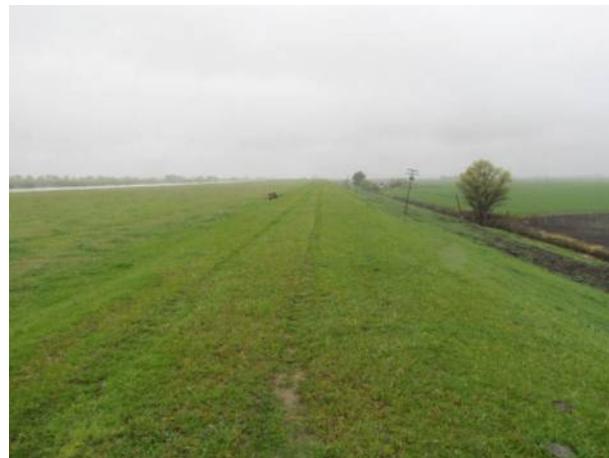
| richard_f_20130918_264.jpg | |

| Looking south at crown roadway. | |

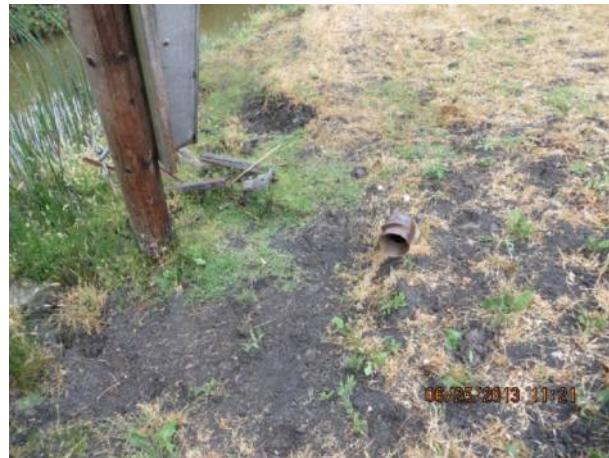
| UCIP_8125.jpg | |

| JP and meter at site of abandoned pump. | |

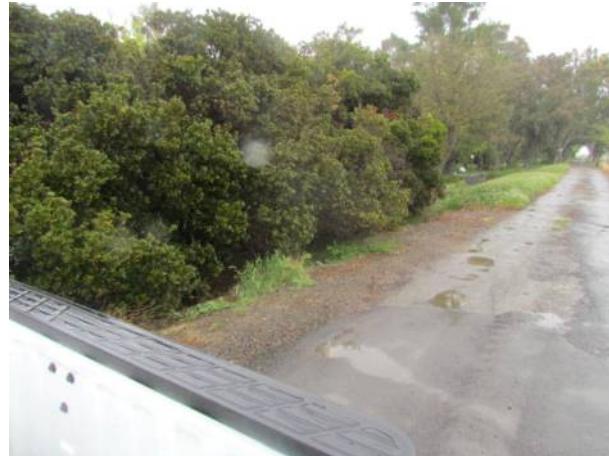
| richard_f_20130918_238.jpg | |

| Looking northwest at dense trees on waterside slope. | |

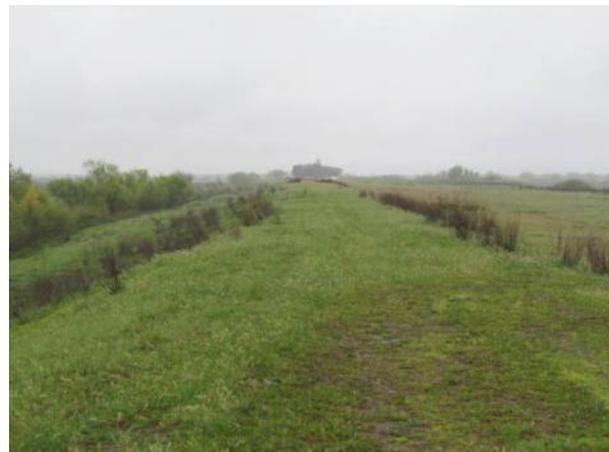
| richard_f_20130918_265.jpg | |

| Looking south at crown roadway. | |

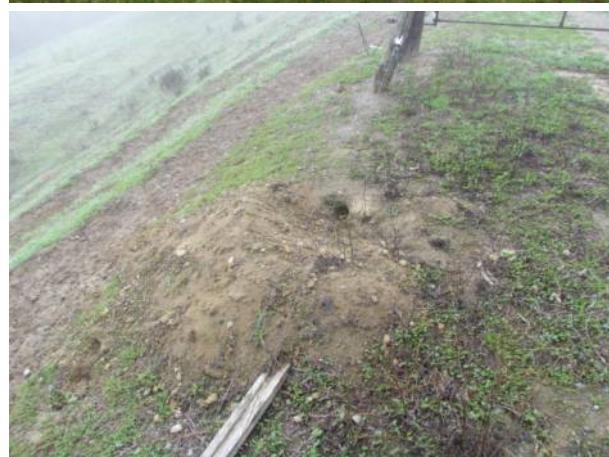
| richard_f_20130918_216.JPG | |

| Looking south at rodent hole on landside shoulder. | |

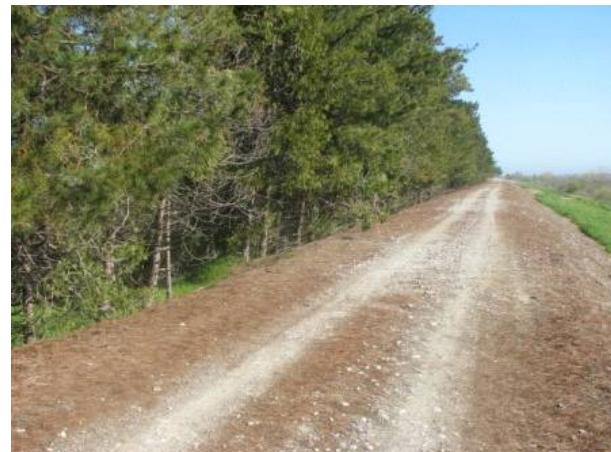
| richard_f_20130918_235.jpg | |

| Pine trees along waterside shoulder & slope. (Site of a old christmas tree farm). (Spring 2011) | |

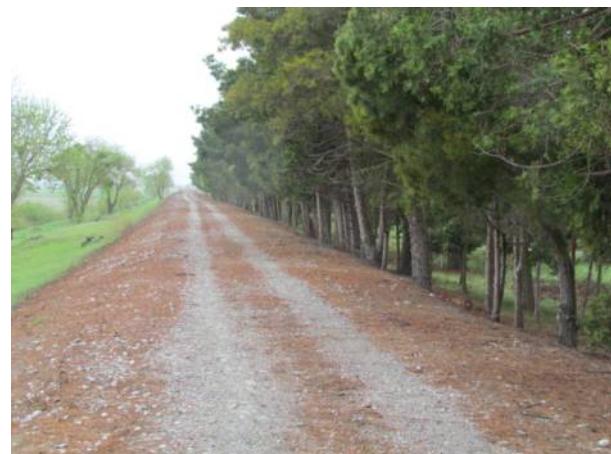
| richard_f_20130918_236.jpg | |

| Looking south at trimmed pine trees on waterside shoulder and slope. (Spring 2012) | |

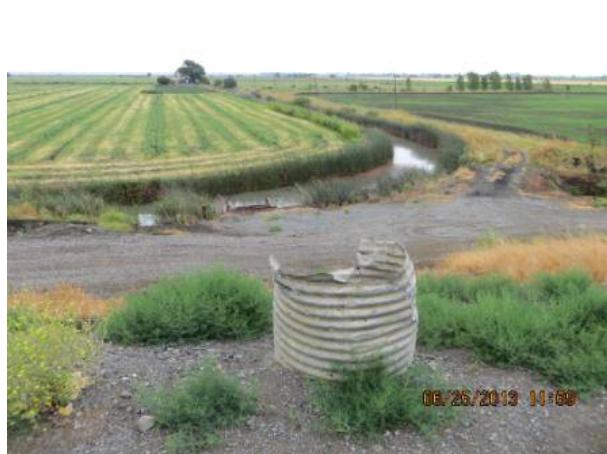
| UCIP_8195.jpg | |

| Siphon breaker in CMP riser on LS shoulder. | |

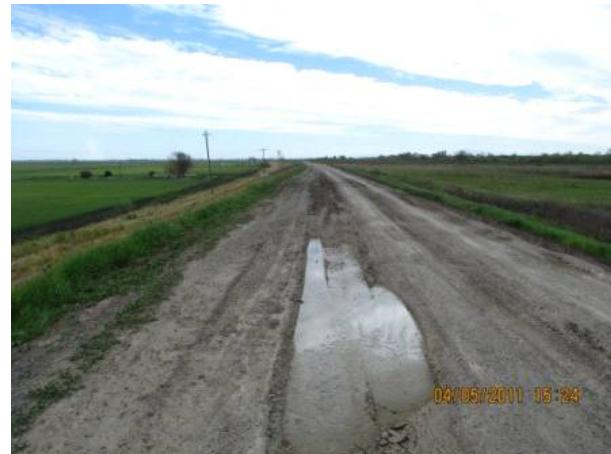
| richard_f_20130918_233.jpg | |

Looking south at rutting on levee crown.

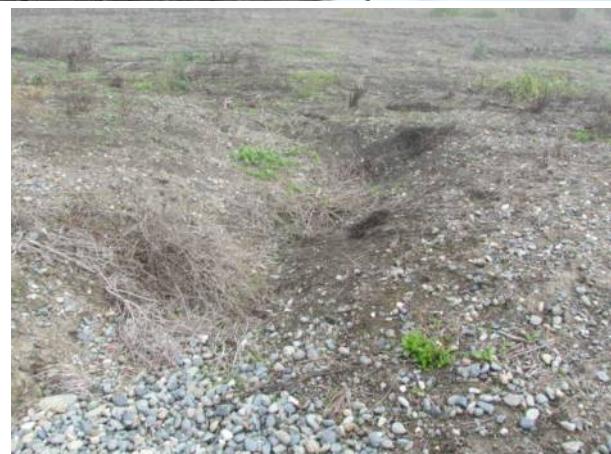
Looking east caving on landside slope.

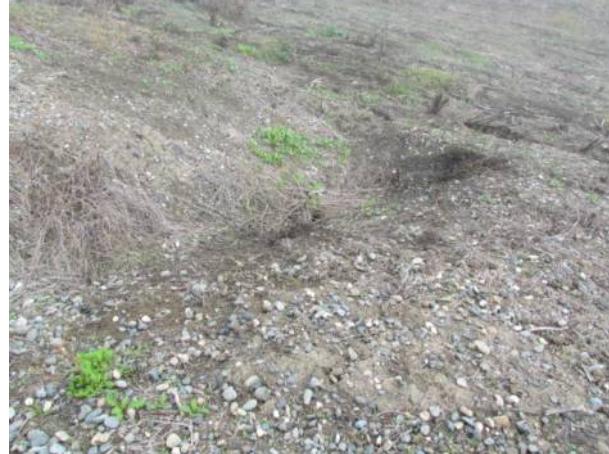
| richard_f_20130918_258.JPG | |

| Looking southeast at caving on landside slope. | |

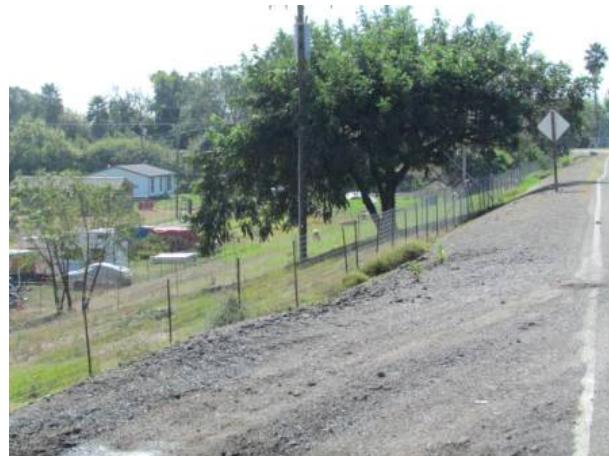
| richard_f_20130918_248.jpg | |

| Looking south at fence along landside slope. | |

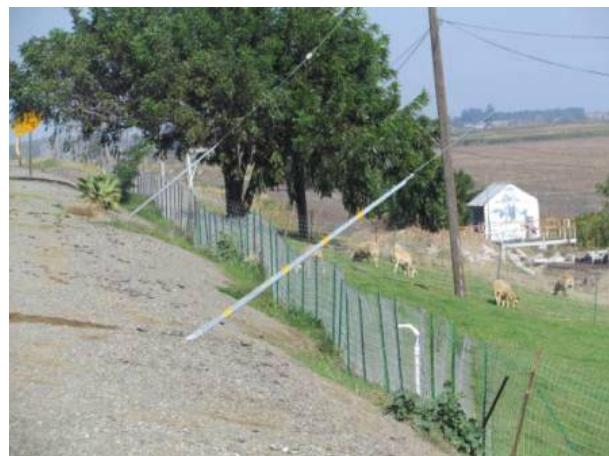
| richard_f_20130918_249.jpg | |

| Looking north at fence along landside slope. | |

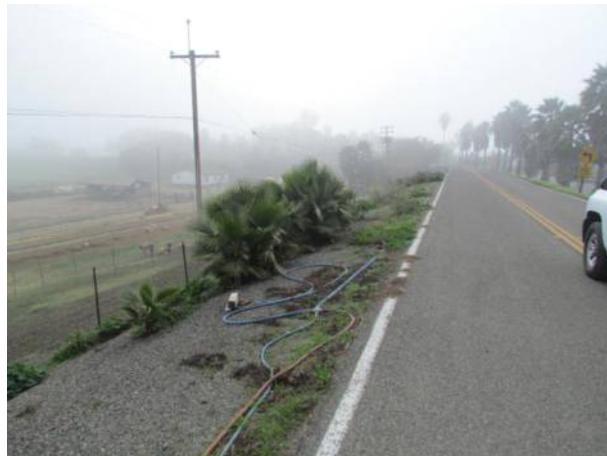
| richard_f_20130918_259.JPG | |

| Looking east at newly planted palm trees on landside shoulder and slope. | |

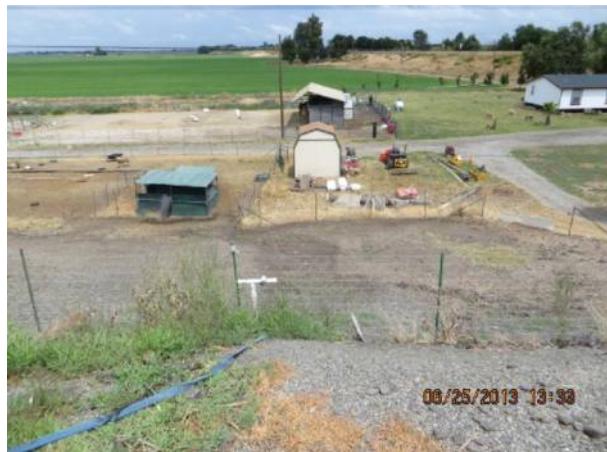
| UCIP_9055.jpg | |

| Pipe visible on LS toe. | |

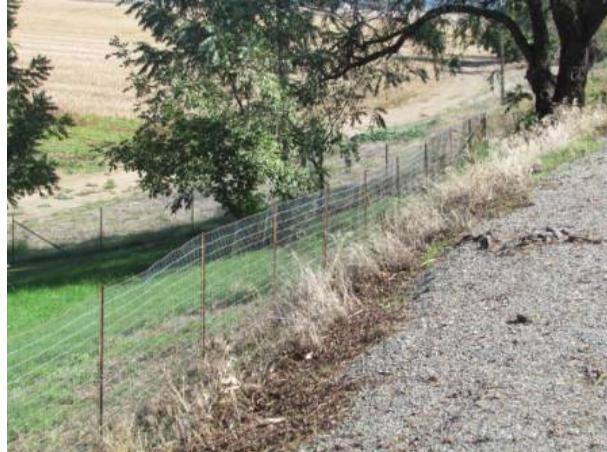
| richard_f_20130918_281.jpg | |

| Looking northeast at fence along landside shoulder. | |

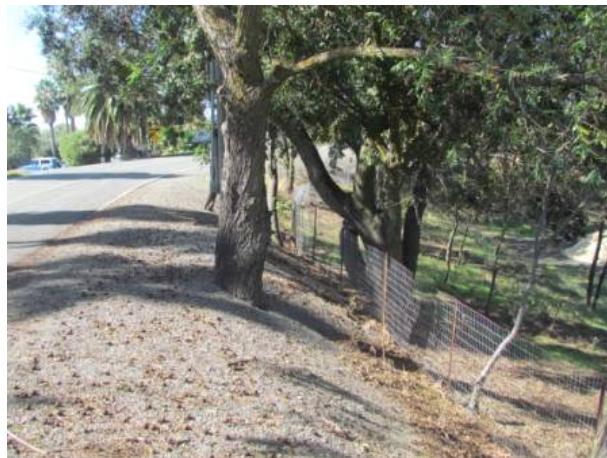
| richard_f_20130918_282.jpg | |

| Looking west at fence along landside slope. | |

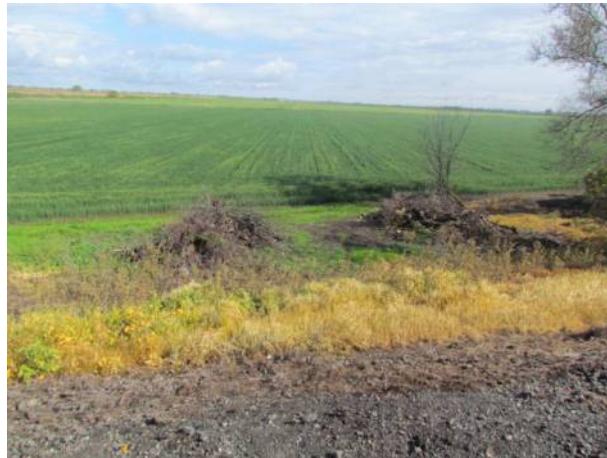
| richard_f_20130918_283.jpg | |

| Looking west at prunings on landside berm. | |

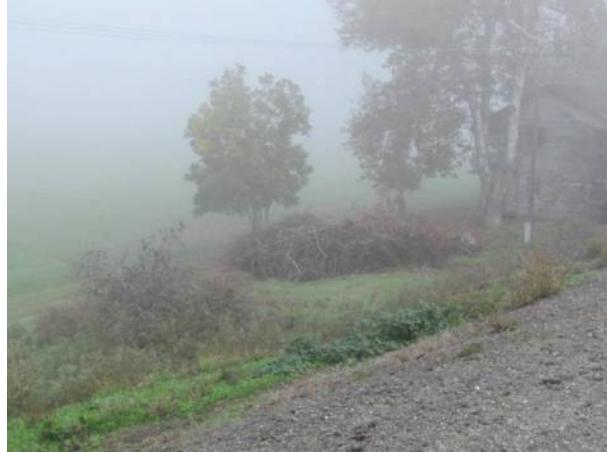
| richard_f_20130918_284.JPG | |

| Looking west at prunings on landside toe. (Fall Inspection 2012) | |

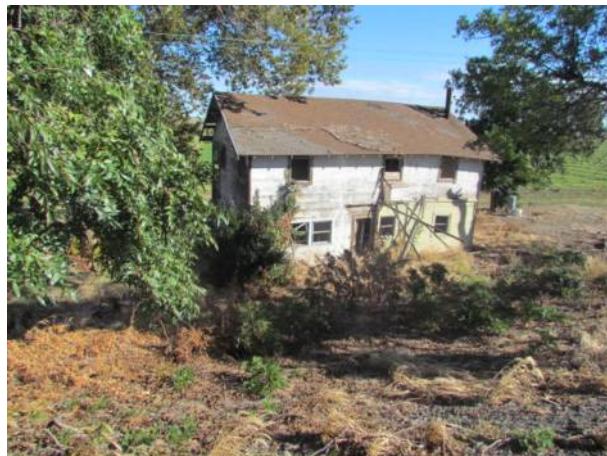
| richard_f_20130927_467.JPG | |

| Looking west at abandoned building on landward berm. | |

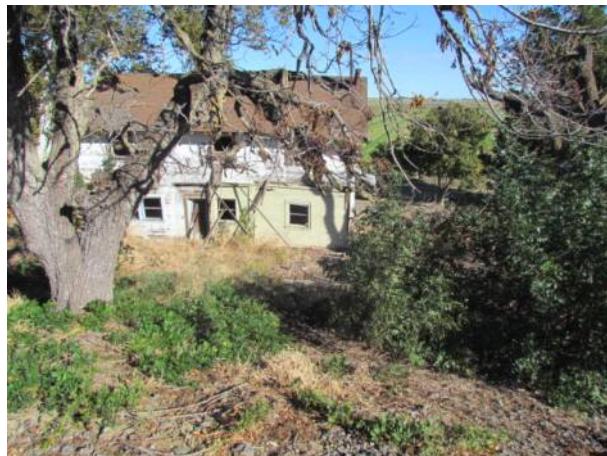
| richard_f_20130927_468.JPG | |

| Looking southwest at abandoned building on landward berm. | |

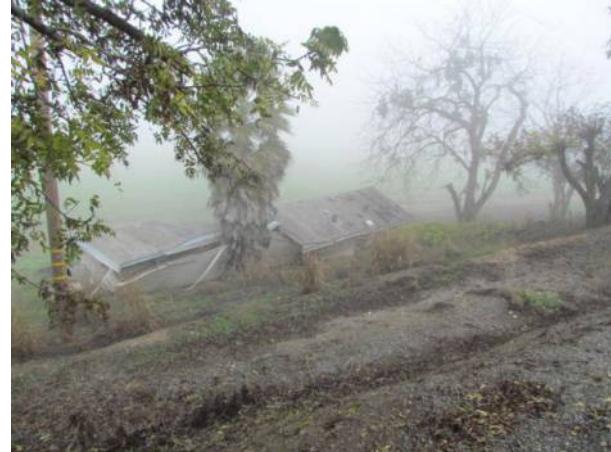
| richard_f_20130918_266.JPG | |

| Looking northwest at dilapidated building at landside toe. | |

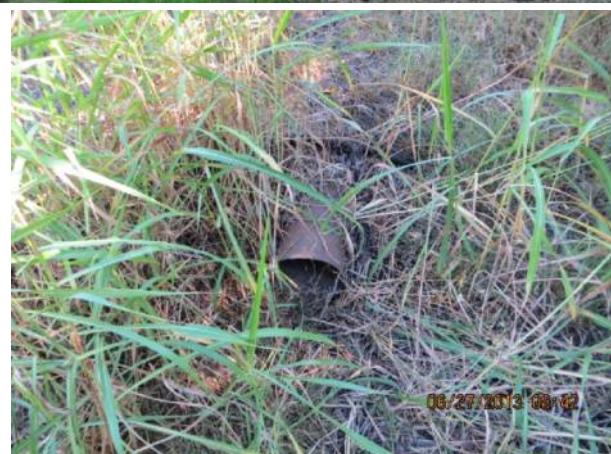
| UCIP_8131.jpg | |

| Pipe visible at concrete pad on WS slope. | |

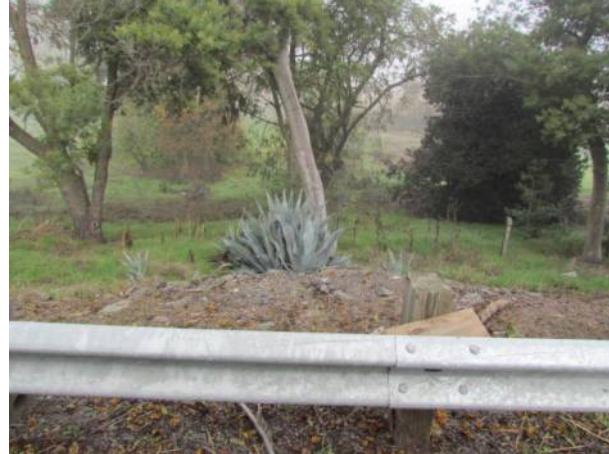
| richard_f_20130918_279.JPG | |

| Looking east at century plant at landside toe. | |

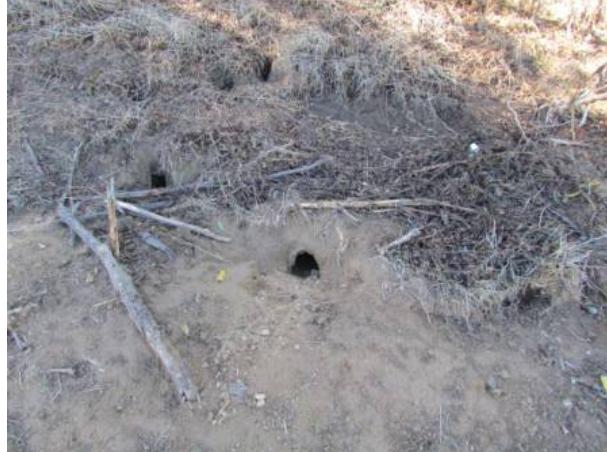
| richard_f_20130918_268.jpg | |

| Looking at several rodent holes on landside slope. | |

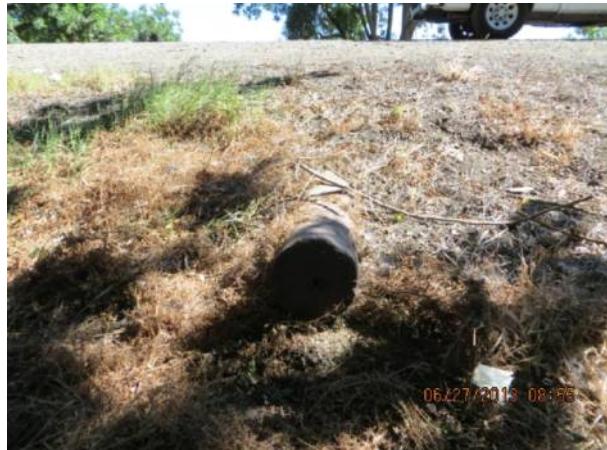
| UCIP_8135.jpg | |

| Pipe with welded steel plate over end visible on WS | |

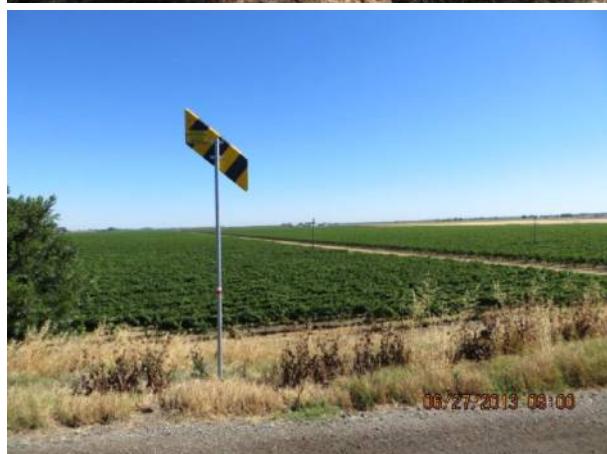
| UCIP_9061.jpg | |

| Gasline marker on LS shoulder. | |

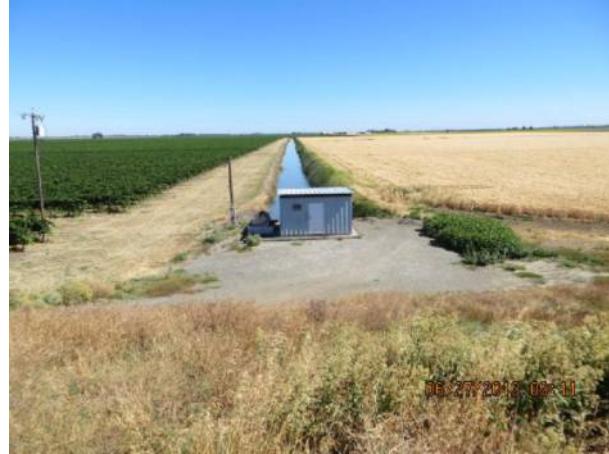
UCIP_9063.jpg

Pumphouse off LS toe.

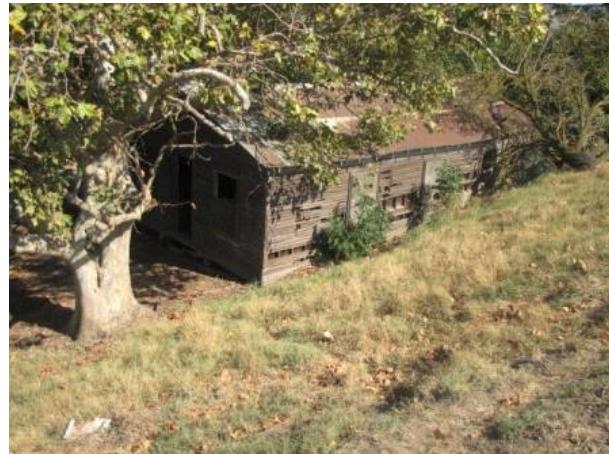
richard_f_20130918_269.jpg

Looking northwest at building at landside toe.

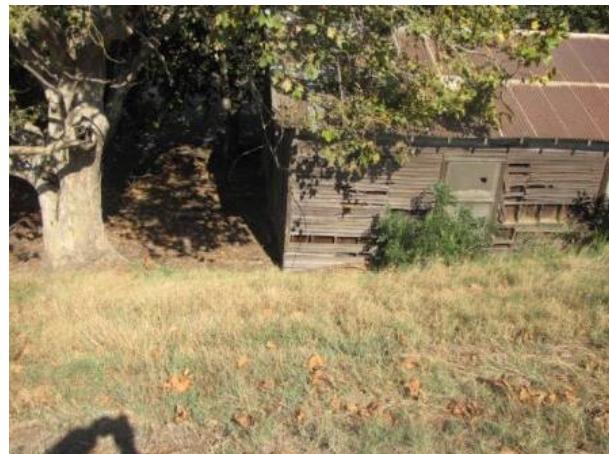
richard_f_20130918_270.jpg

Looking west at building at landside toe.

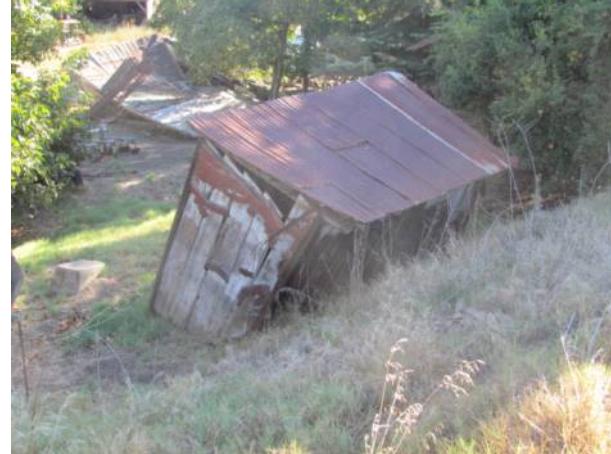
| richard_f_20130927_469.JPG | |

| Looking northwest at abandoned pump house on landward toe. | |

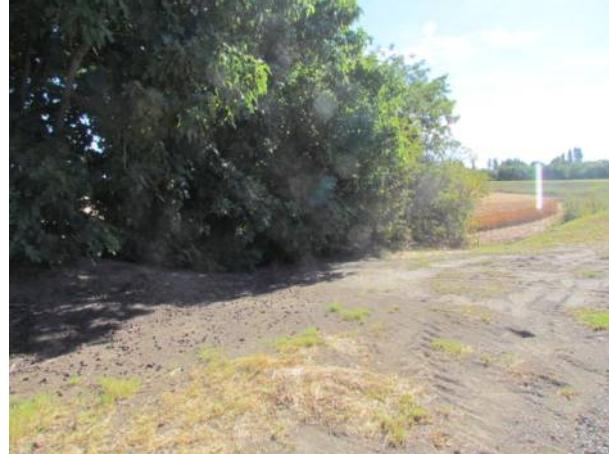
| richard_f_20130927_471.JPG | |

| Looking north at dense trees on landward slope and toe. | |

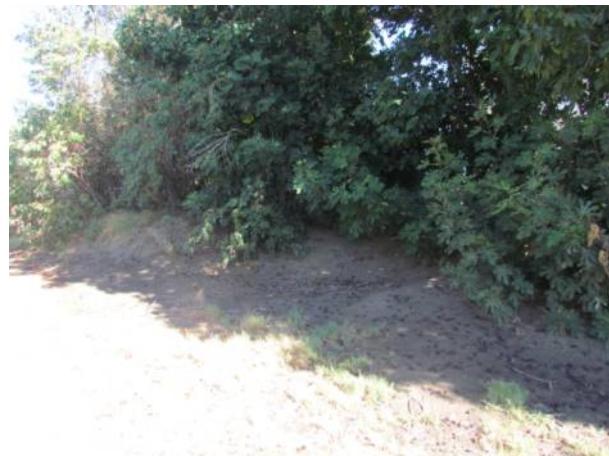
| richard_f_20130927_472.JPG | |

| Looking southwest at dense trees on landward slope and toe. | |

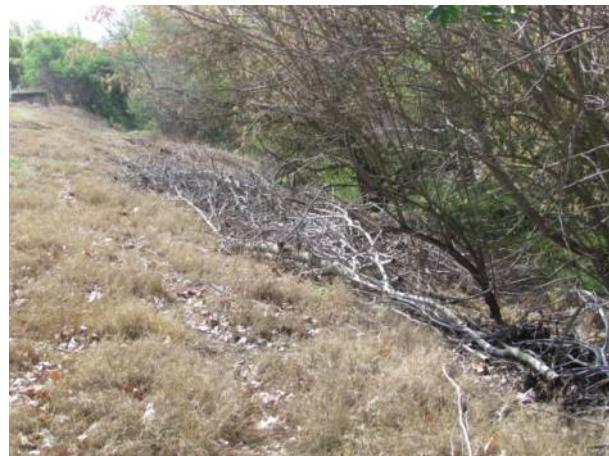
| richard_f_20130918_286.jpg | |

| Looking northeast at prunings on waterside slope. | |

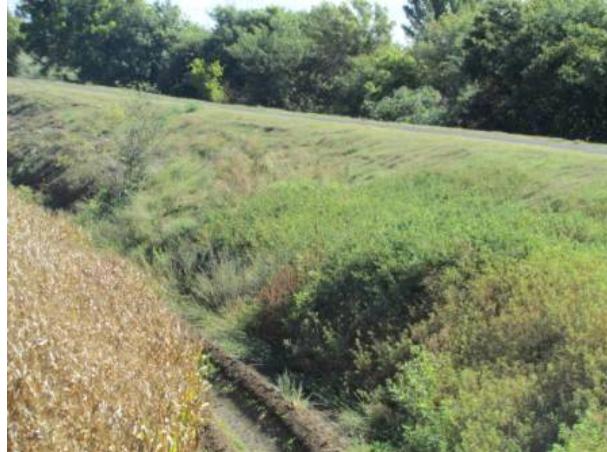
| richard_f_20130918_272.jpg | |

| Looking east at dense wild roses on landside toe. (Spring 2011) | |

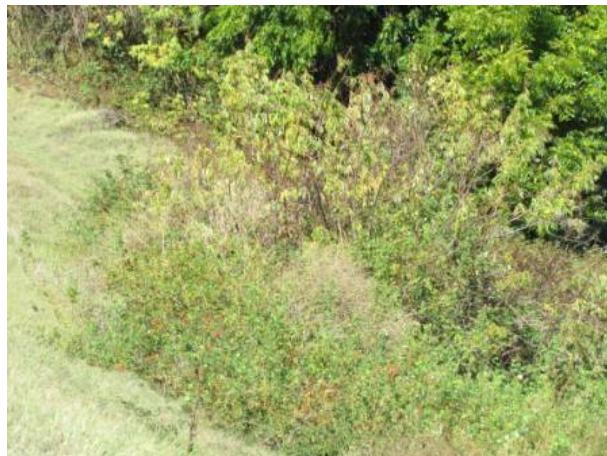
| richard_f_20130918_273.jpg | |

| Looking north at wild roses on landside toe. (Spring 2011) | |

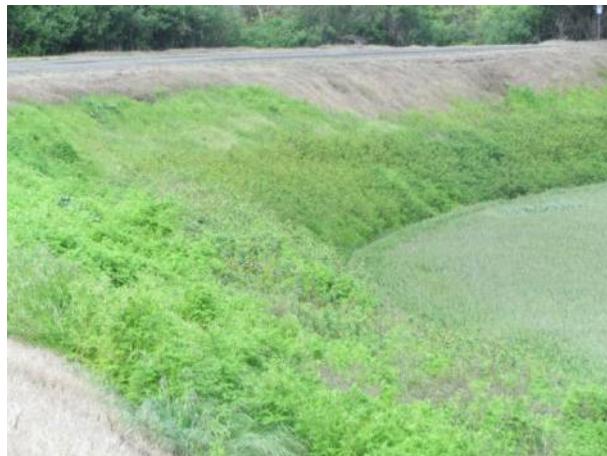
| richard_f_20130918_274.jpg | |

| Looking southeast to wild roses on landside slope and toe. (Spring 2012) | |

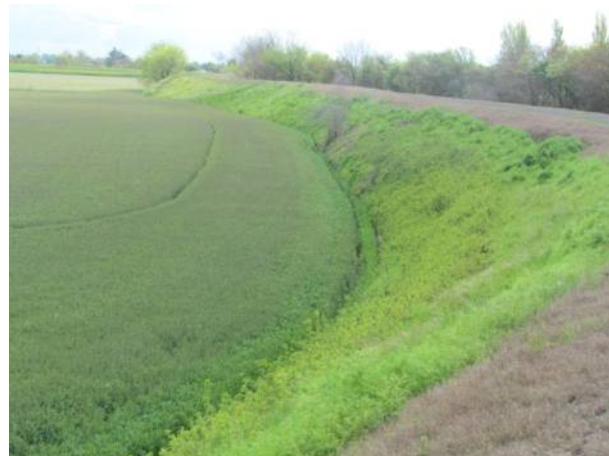
| richard_f_20130918_287.jpg | |

| Looking north at crops encroaching onto landside toe. | |

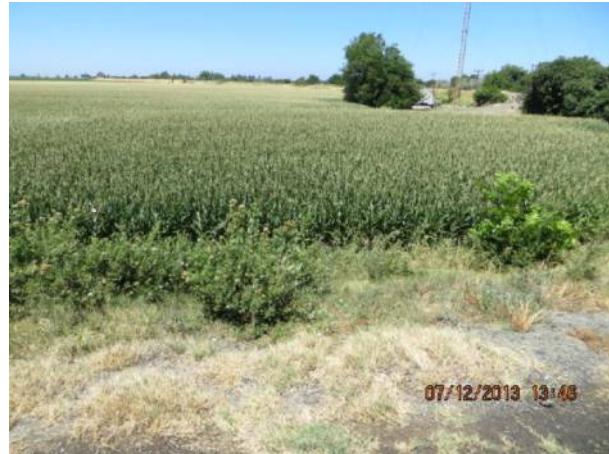
| Pipe visible just off shoulder on LS slope in the rose bushes. | UCIP_8609.jpg |

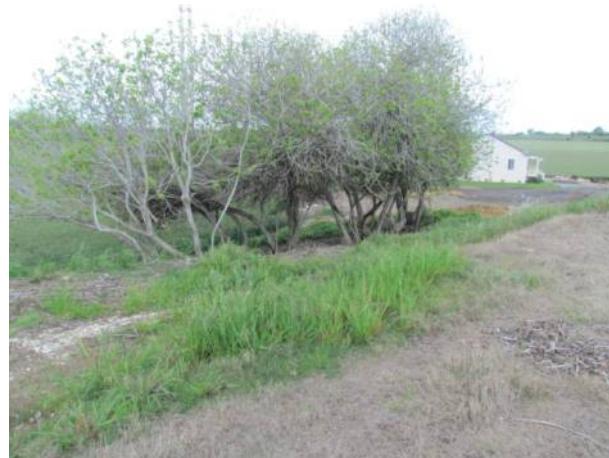
| richard_f_20130918_300.jpg | |

| Looking southwest at trimmed trees on landside toe. (Spring 2012) | |

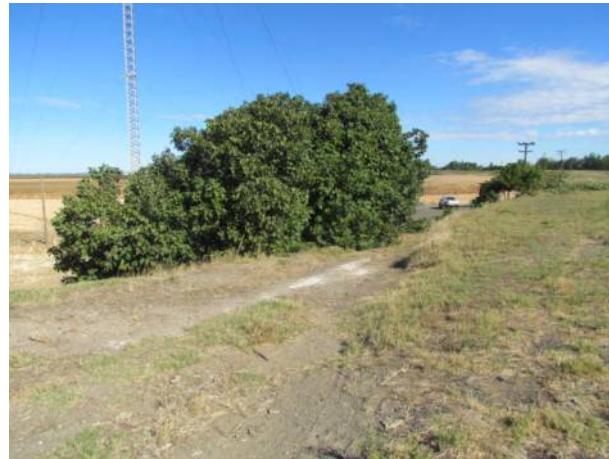
| richard_f_20130927_475.JPG | |

| Looking northwest at dense fig tree on landward slope and toe. 2013 | |

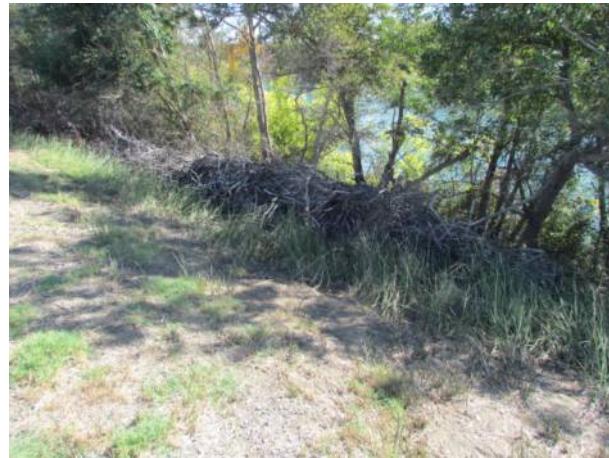
| richard_f_20130927_476.JPG | |

| Looking east at prunings on waterward slope. | |

| Waterway | | | | | | | | Bank | Unit Miles | Inspection Start/End | Inspector |
|---|---|---|---|---|---|---|--|---|---|---|---|
| 2 | 0.04 | 0.04 | Earthen Levee | Encroachments | WS Ma | M | PR : Prunings Inspector Comments: Prunings on waterward slope outside the twenty feet zone should be burned or removed from levee slope. | ° ° | ° ° | 36 Y | |

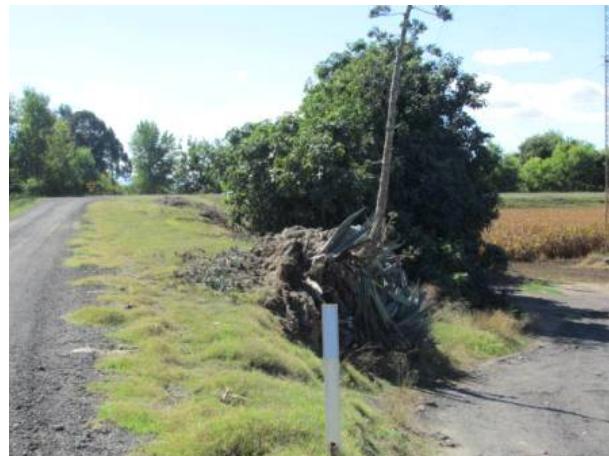
| richard_f_20130918_304.jpg | |

| Looking east at partially dead cactus plant on landside slope during 2011 fall inspection. | |

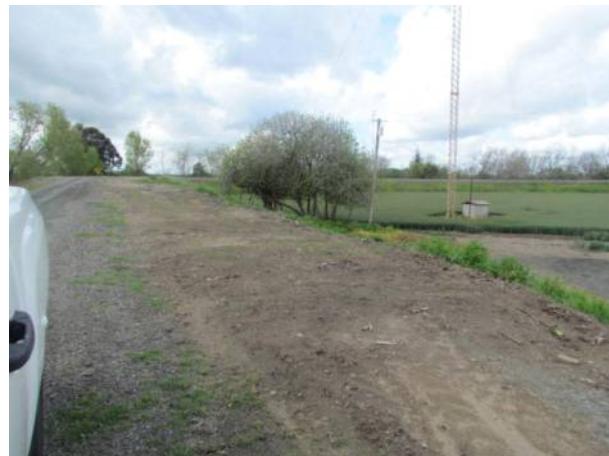
| richard_f_20130918_305.jpg | |

| Looking east at removed cactus on landside slope during 2012 spring inspection. | |

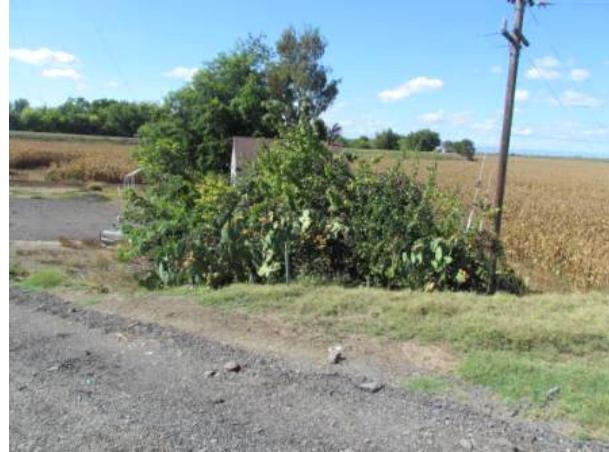
| richard_f_20130918_294.jpg | |

| Looking west at dense vegetation on landside slope near ramp. (Spring 2011) | |

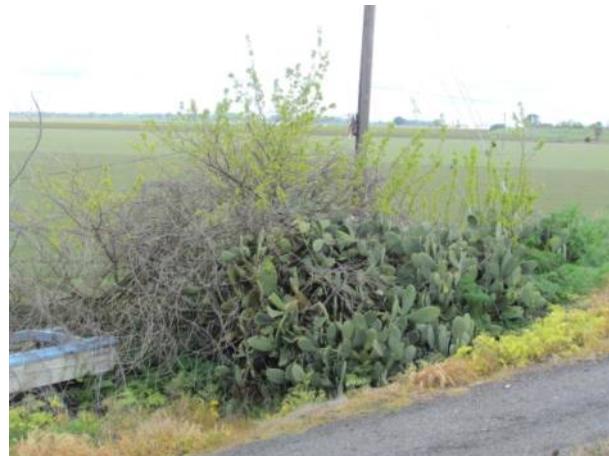
| richard_f_20130918_295.jpg | |

| Looking southwest at dense vegetation and cactus on landside slope. (Spring 2012) | |

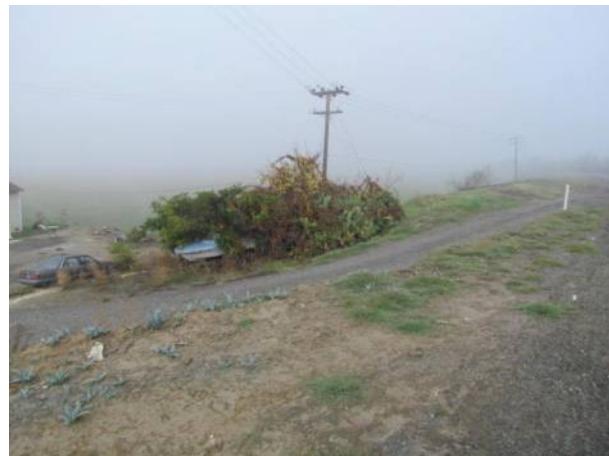
| richard_f_20130918_296.JPG | |

| Looking northeast at vegetation on landside slope and toe. (Fall Inspection 2012) | |

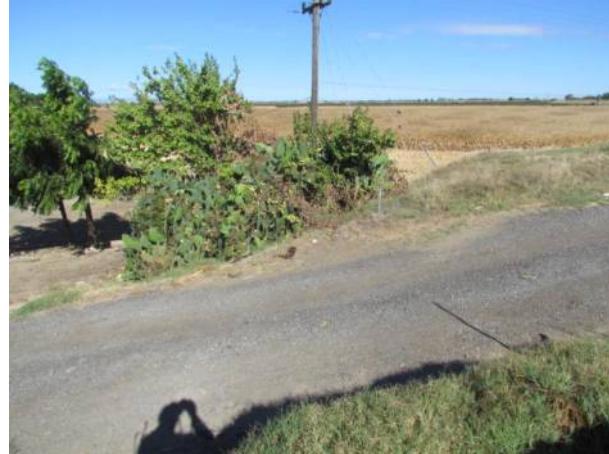
| richard_f_20130927_477.JPG | |

| Looking southwest at dense cactus plants on landward slope. | |

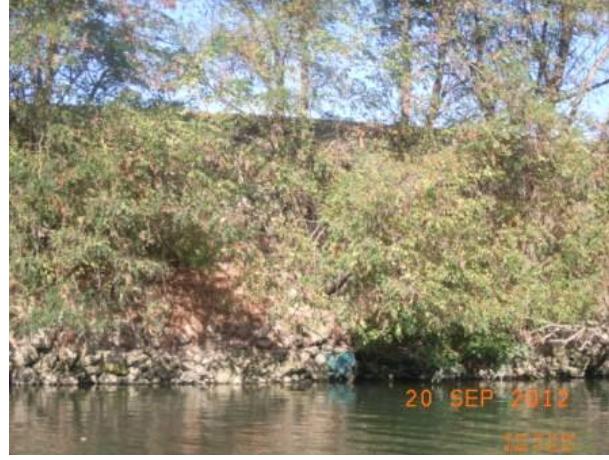
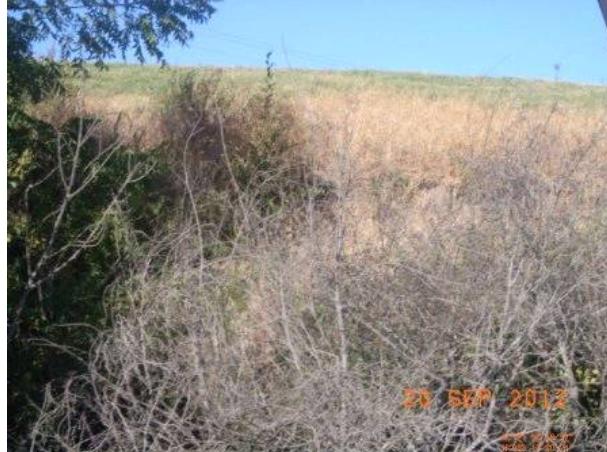
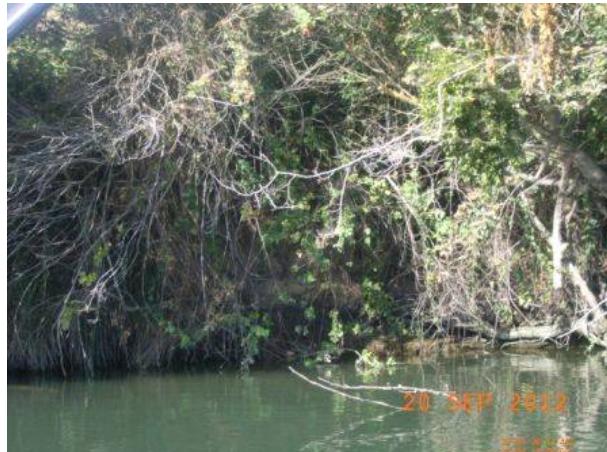
| USACE 2012 Photo #1 | |

| Waterway | | | | | | | | Bank | Unit Miles | Inspection Start/End | Inspector |
|---|---|---|---|---|---|---|--|---|---|---|---|
| 8 | 0.21 | 0.21 | Supplemental Survey | USACE Erosion | WS Ma | M | Inspector Comments: 1997 - Intermittent over-steepened sections. Large riparian vegetation along the length of the entire reach. Attempts to repair with rock on bank have failed. 1999 - New rock repair at the downstream end. 2002 - Some minor spot repairs. 2009 - Minimal new erosion. 2010 - Appears that fresh rock placed on downstream portion of site. Toe scour and overhanging trees with some overturned. 2012: Minor new erosion at the toe. [2012 Site ID: STR_24-7_R] | 38.295505 ° -121.605648 ° | 38.289634 ° -121.604343 ° | 29 Y | |

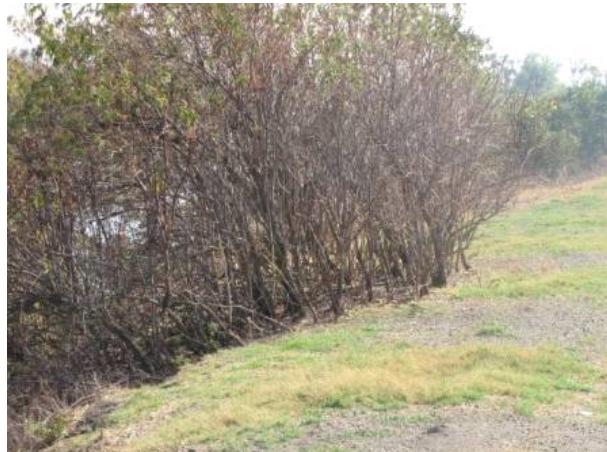
richard_f_20130918_306.jpg

Looking south at thinned Elderberry on waterside slope.
